Glenn Home Inspections

HOME INSPECTION REPORT

1234 Main St.

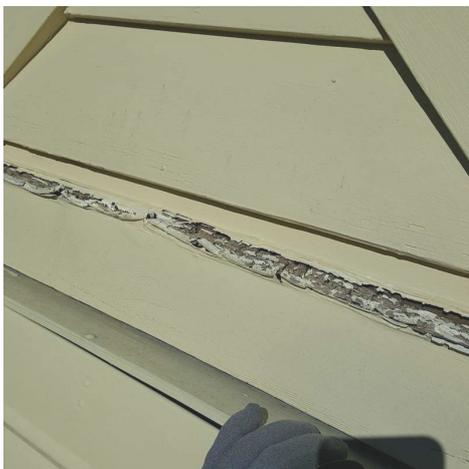
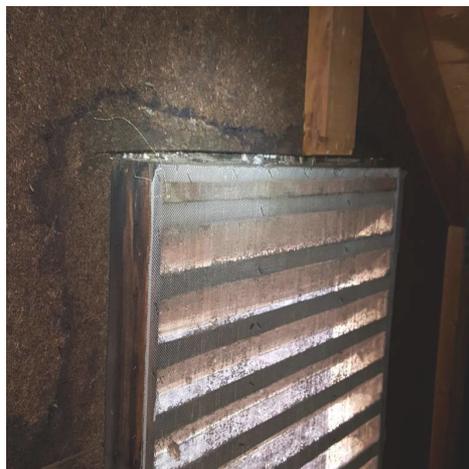
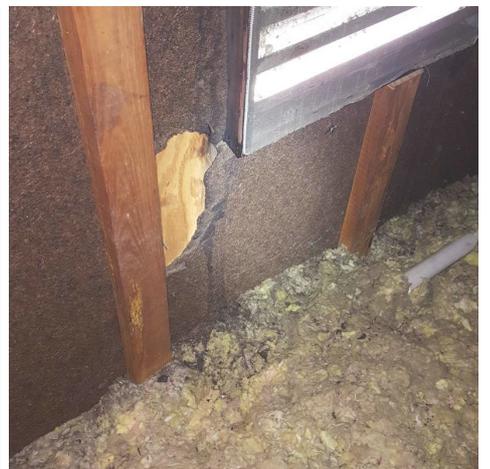
3.2.3 Siding, Flashing & Trim

Rotting siding / trim can allow water entry which can cause hidden damage. Areas above the installed attic vents are rotted and allowing water entry. Have a qualified contractor locate and replace all rotted siding / trim on the house. The areas behind any rotted areas should be fully evaluated for water damage and repaired as necessary.

Contact a qualified carpenter.

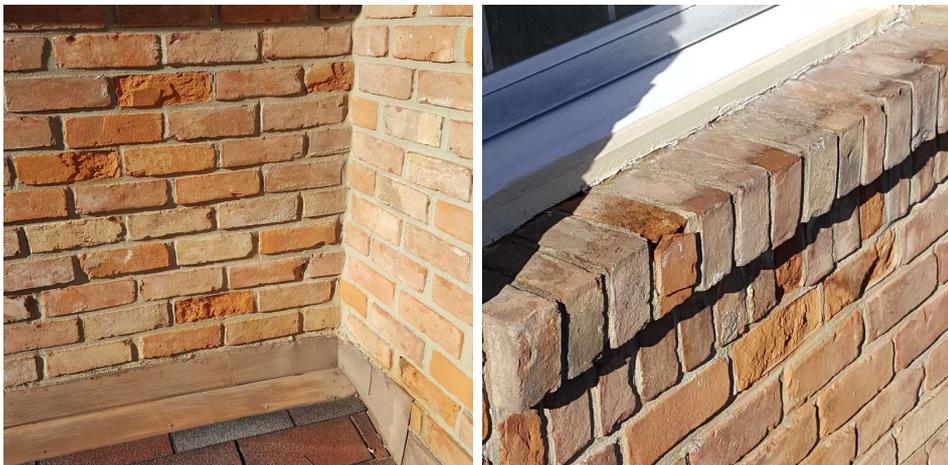
3.2.4 Siding, Flashing & Trim

DAMAGED BRICK

The brick is damaged. Once the brick face has come detached the brick is no longer sealed. Water will easily absorb and release from the area. Water can absorb into the home. The condition will only worsen and can damage subsequent bricks. Rebuilding areas will be necessary as replacing the bricks is the only resolution.

Contact a qualified masonry professional.

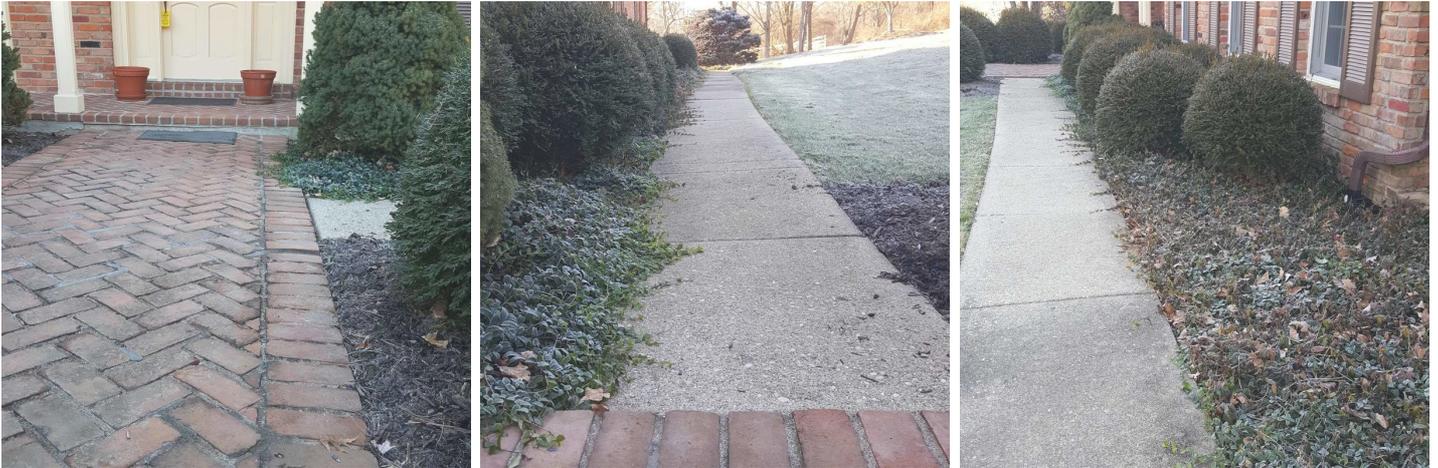
When a hard surface such as a sidewalk or patio slopes toward the house it can direct a very large amount of water towards the foundation. Over time this water can cause foundation damage. **SEE ALSO FOUNDATION** - *Foundation cracks, water entry, and past waterproofing is noted in the adjacent area in the basement.* **SEE ALSO GRADING** - *The grade needs adjustment and this sidewalk may prevent properly correcting the grade without removal and replacement.*

There are several options to repair this condition.

1. Slab jack or lift the concrete.
2. Remove and replace the concrete.
3. Remove the concrete and install pavers/bricks and gravel or some other type of system more easily manipulated.

Contact a qualified contractor to make the repair you choose.

Contact a qualified concrete contractor.

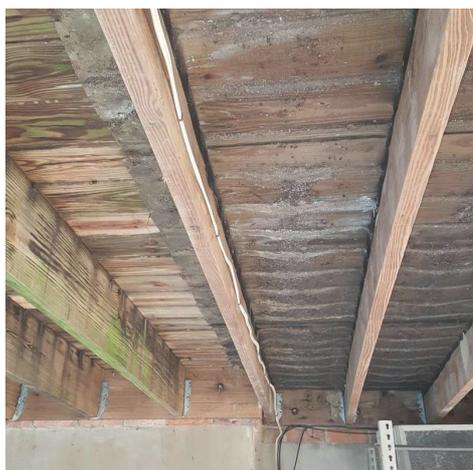
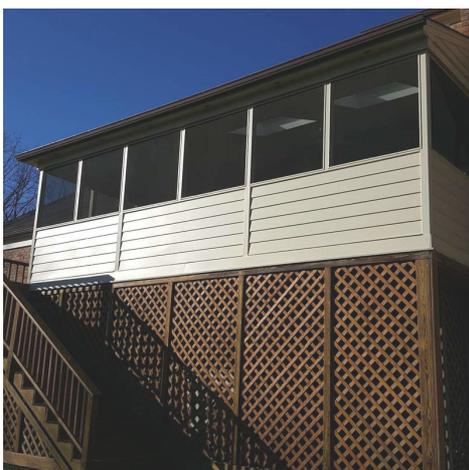
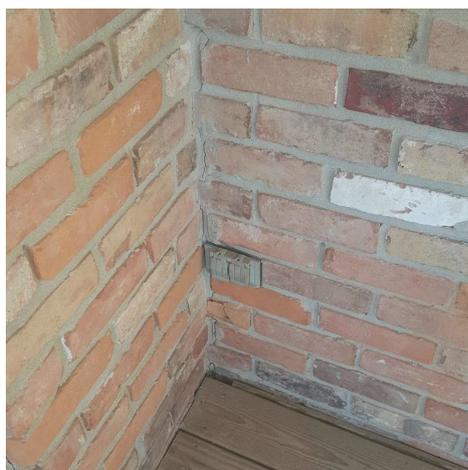
IMPROPER ROOM ADDITION CONSTRUCTION PRACTICES

Deck was observed to be installed in a manner that is not recommended. A room structure has been added to the deck without any additional load bearing provisions having been added. A portion of the wall structure that also supports the roof above is supported only by the decking boards. No joists have been doubled and the wall does not rest on a joist. Stress cracking can be seen at the brick veneer and the foundation in immediate area.

A structural engineer needs to evaluate the entire roof structure and supporting deck to provide all recommendations for proper structural support. A qualified contractor should implement all recommended repairs. The engineer should return to certify all installed repairs.

Contact a qualified structural engineer.

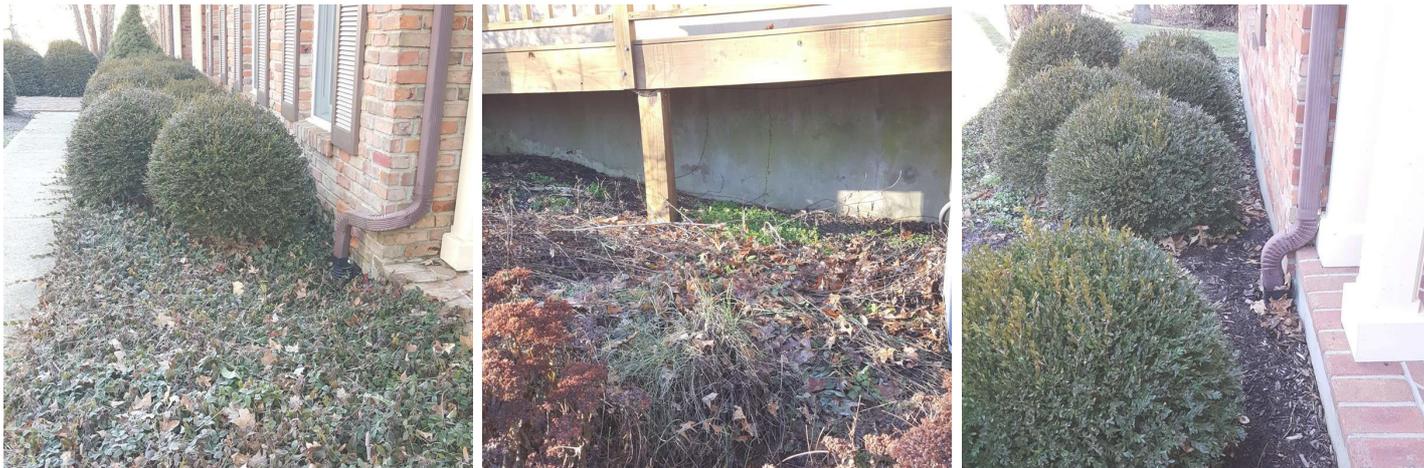
Grading is sloping towards the home in some areas. Directing more moisture towards the foundation increases the risk of moisture intrusion and subsequent foundation issues. **SEE ALSO FOUNDATION - Foundation cracks, water entry, and past waterproofing is noted in the adjacent area in the basement.**

Water should be directed away from all standing foundations to prevent potential water intrusion. The drainage strategy of the foundation is important. The minimum recommendation is 1/2in / Foot for 10 feet in grade slope. The soil should not be raised more than 4 inches below the top of the foundation.

Recommend regrading the area to achieve a slope away from the home. If regrading is not possible, add drain tile to re-direct water away from the home.

Contact a qualified grading contractor.

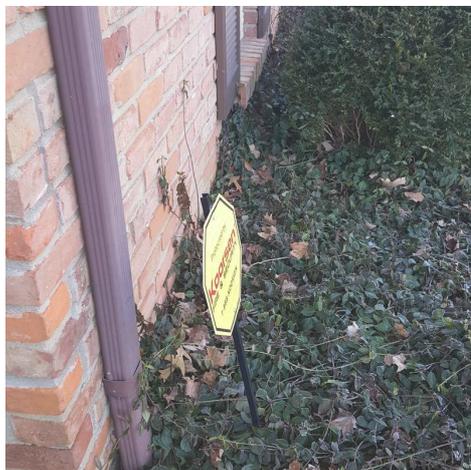
3.8.2 Vegetation, Grading, & Drainage

SOIL IS RAISED HIGHER THAN THE FOUNDATION

High soil levels surrounding the house can cause water damage to wood framing and brick and create an easy access point for termite infestation or mice. **SEE ALSO WALL STRUCTURE** - *Damage was noted to the wall structure and termite infestation is noted in this area.*

Recommend lowering the soil level to 4 inches or more below the top of the foundation. The proper slope of grade away from the house should be maintained. The minimum recommendation is 1/2in / Foot for 10 feet in grade slope. If grade slope can not be maintained, add drain tile to re-direct water away from the home.

Contact a qualified landscaping contractor

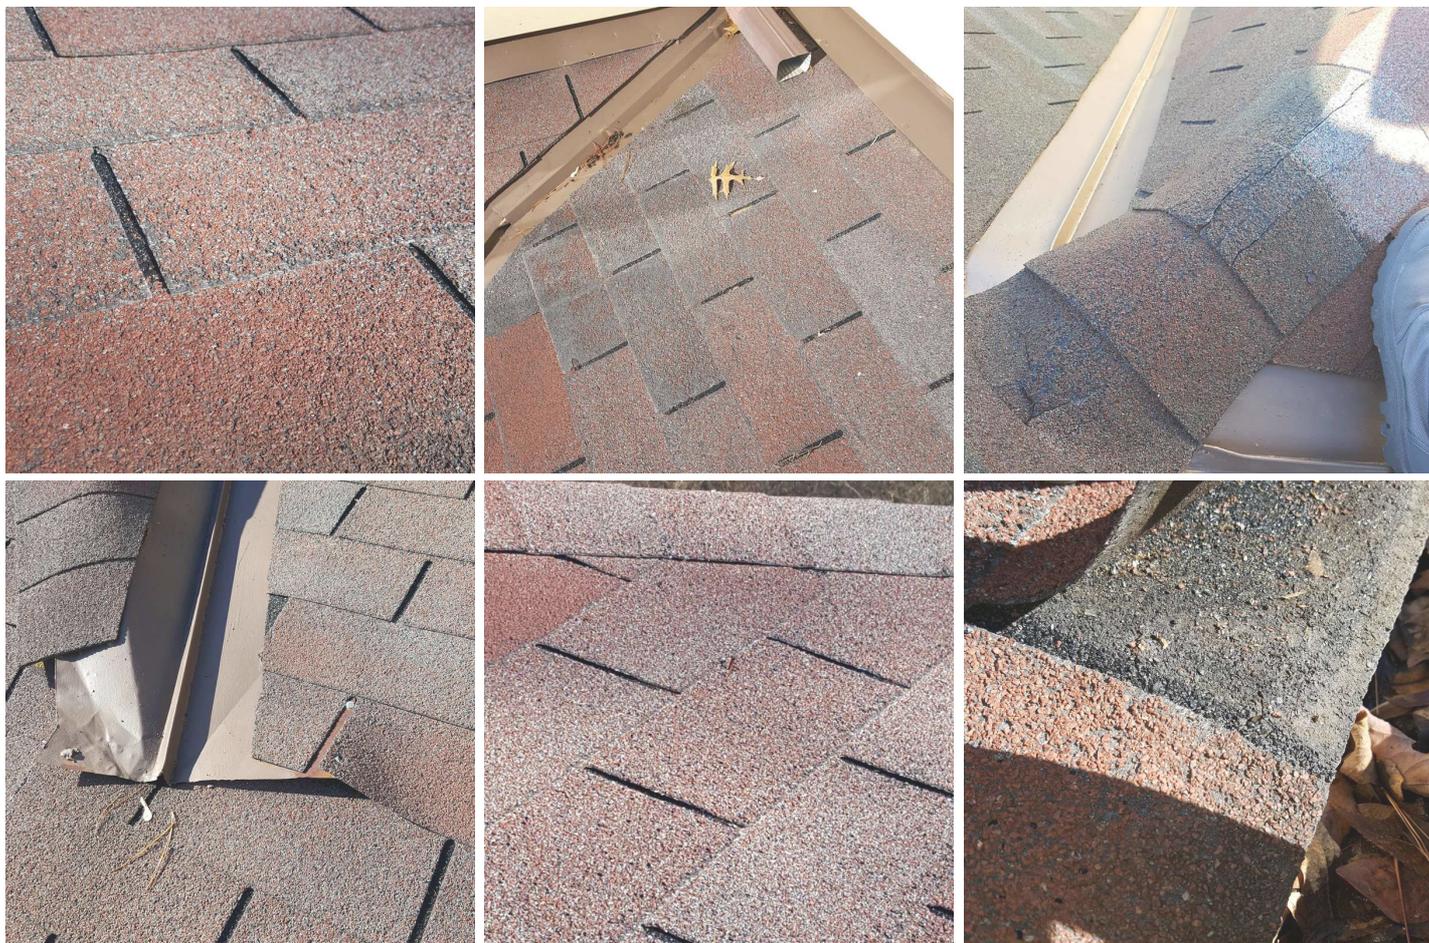
This roof shows one or more conditions consistent with being near end of life. Damaged shingles, granule loss, loose flashing, and persistent leaking at the garage is noted. Budget to replace the roof in the near future. If obtaining a roofing inspection, be certain the roofing company provides a written remaining life estimate; if any. If replacement is not opted for at this time a full evaluation to determine necessary immediate repairs should take place and subsequent yearly inspections take place.

Contact a qualified roofing professional.

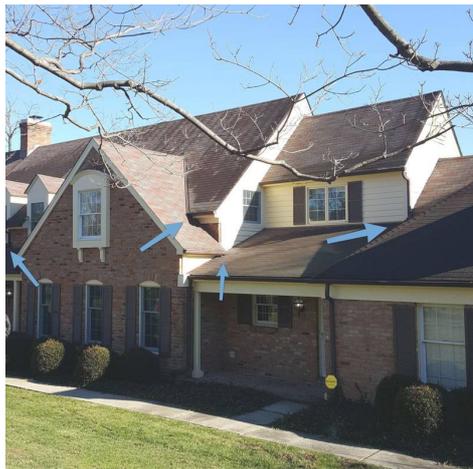
This is common practice done for aesthetic reasons but is not recommended. This can deteriorate the roof leading to early leaks and also void the shingle manufacturer warranty.

Recommend routing the gutter so it empties into the gutter below.

Contact a qualified gutter contractor

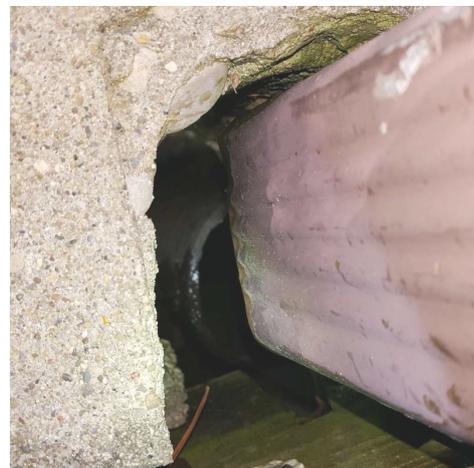
Leakage can occur damaging the house or foundation over time. **SEE ALSO DECK** - Significant damage has occurred to the adjacent deck.

Recommend fully connecting all downspouts.

Contact a handyman or DIY project

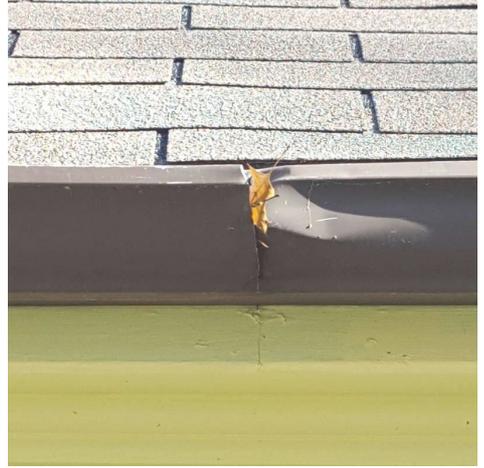
4.6.4 Gutters / Downspouts

GUTTER DAMAGED

Gutters were damaged. This can result in excessive moisture in the soil at the foundation, which can lead to foundation/structural movement or water entry and damage to the structure. **SEE ALSO WALL STRUCTURE** - Damage to the adjacent wall structure is noted and termite activity is noted in the attic in the adjacent area of one damage portion.

Recommend a qualified contractor evaluate and repair.

Contact a qualified gutter contractor

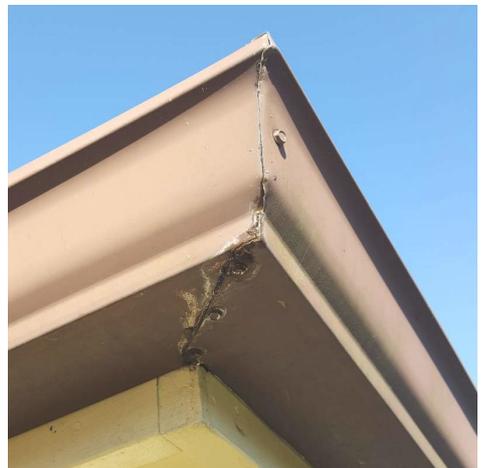
4.6.5 Gutters / Downspouts

GUTTER LEAKAGE

Gutters were observed to be leaking in one or more areas. This can result in excessive moisture in the soil at the foundation or deterioration to the deck below. This can also cause ice buildup and become a safety hazard. Recommend a qualified contractor evaluate and repair gutters to proper functionality.

Contact a qualified gutter contractor

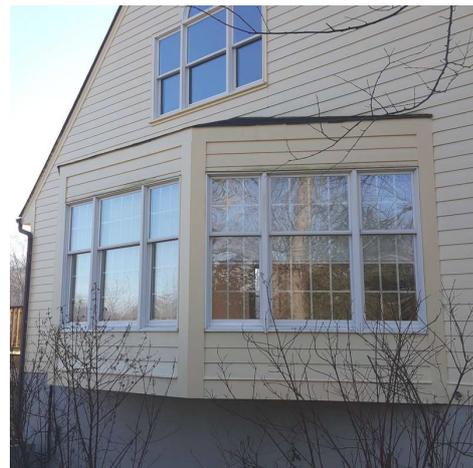
4.6.6 Gutters / Downspouts

GUTTERS MISSING

There are no gutters present on the bay window. There is significant water damage noted to the trim and windows and evidence of water intrusion in the area below. Gutters are recommended because they collect rain water from the roof and direct it away from the building.

Contact a qualified gutter contractor

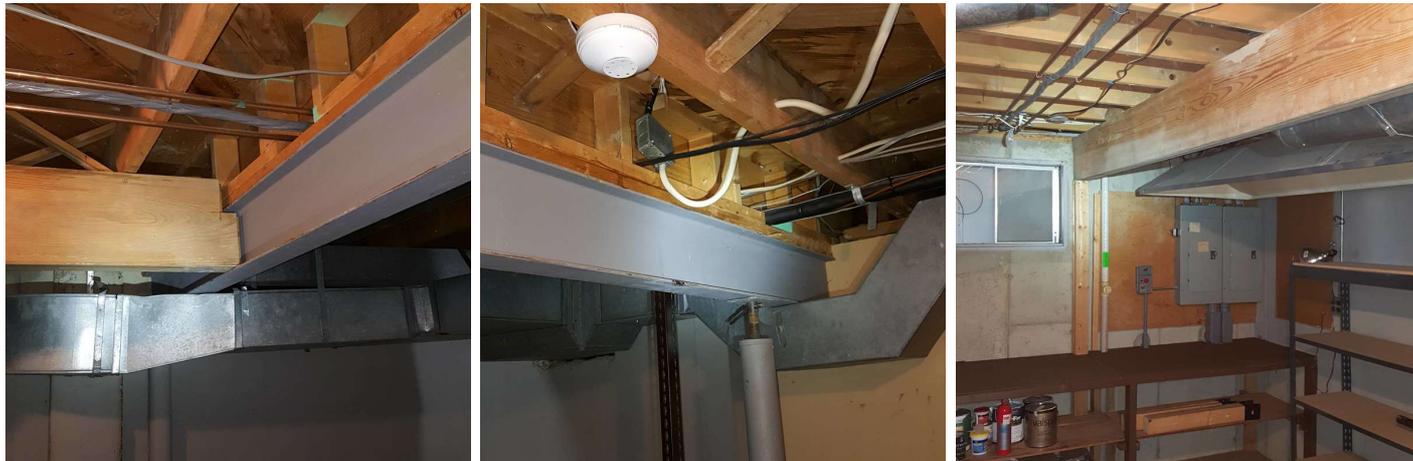
Basement Right Side

Previous repairs have been made to the floor structure below the kitchen. A steel beam has been added and a double beam has been added. Inquire with the seller as to the reason for these repairs and obtain design documents for this repair. If design documents are not available have the repair evaluated by a structural engineer.

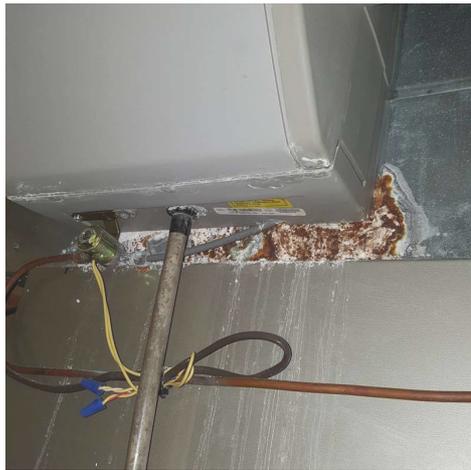
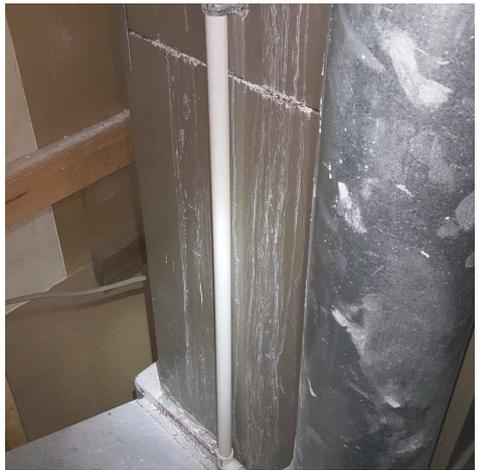
11.2.1 Humidifier

The humidifier is leaking and may damage the furnace cabinet or internal components. Have a licensed HVAC contractor repair.

Recommendation
Contact a qualified professional.
